PRINCETON NURSERIES KINGSTON SITE CULTURAL LANDSCAPE REPORT  
CHAPTER III: RECENT HISTORY & EXISTING LANDSCAPE

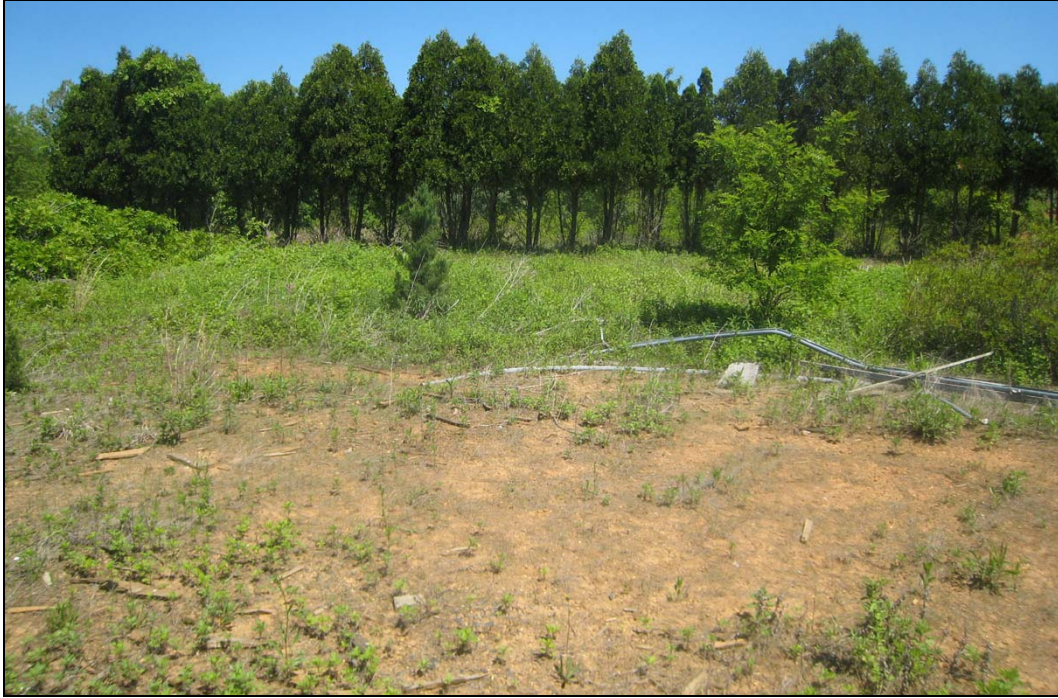
Figure III.23. Volunteer vegetation is also evident in this former production field although the ground plane is more open with large patches of bare soil. A row of arborvitae grows at the field edge. Courtesy Heritage Landscapes. (R-PRN-19May09-0110.JPG)

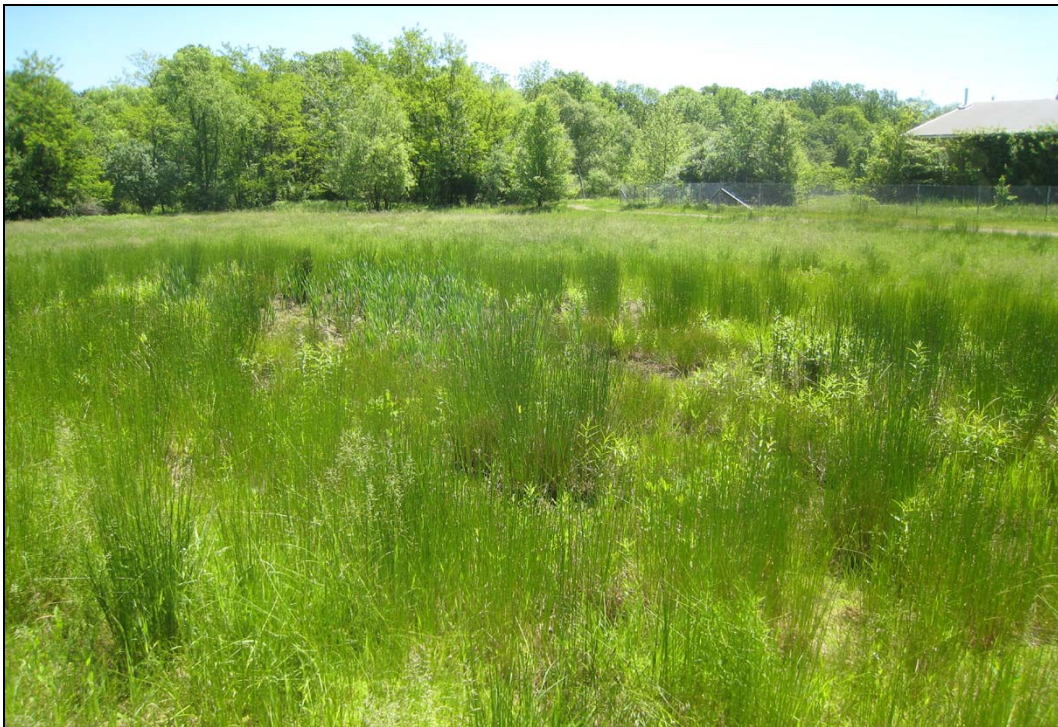
Figure III.24. A change in vegetative cover to a wetland species through the center of the former wholesale distribution yard indicates a change in natural hydrology. Courtesy Heritage Landscapes. (R-PRN-19May09-0080.JPG)

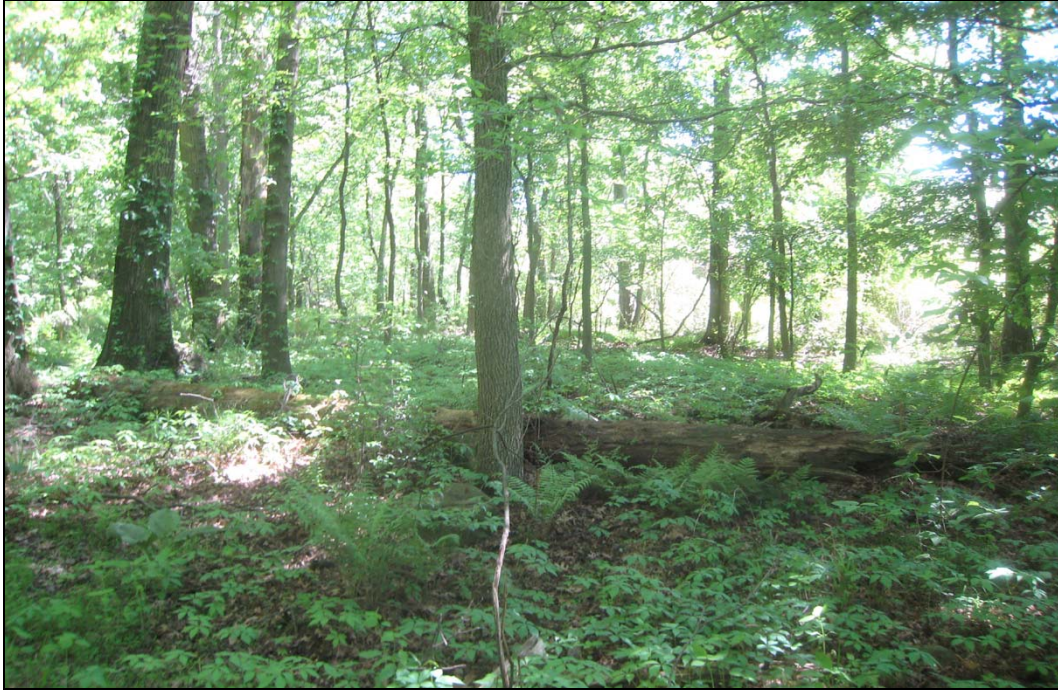
Figure III.25. A woodland that existed throughout the Princeton Nurseries history remains at the eastern edge of Mapleton Preserve. Although no formal trails provide access through the wooded area, it does create a scenic character that differs from the broader landscape. Courtesy Heritage Landscapes. (R-PRN-19May09-0128.JPG)

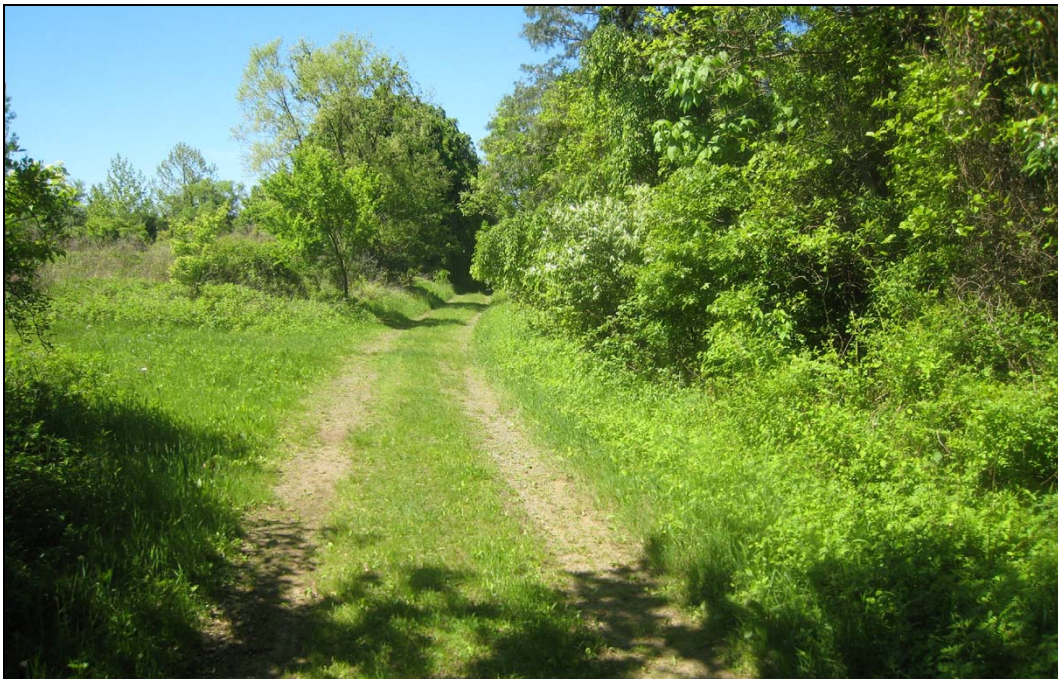
Figure III.26. This section of road is located at the southeast edge of Mapleton Preserve. Overall the road is surfaced in gravel while this southern portion is a mix of gravel and compacted dirt with a central turf panel. Courtesy Heritage Landscapes. (R-PRN-19May09-0131.jpg)

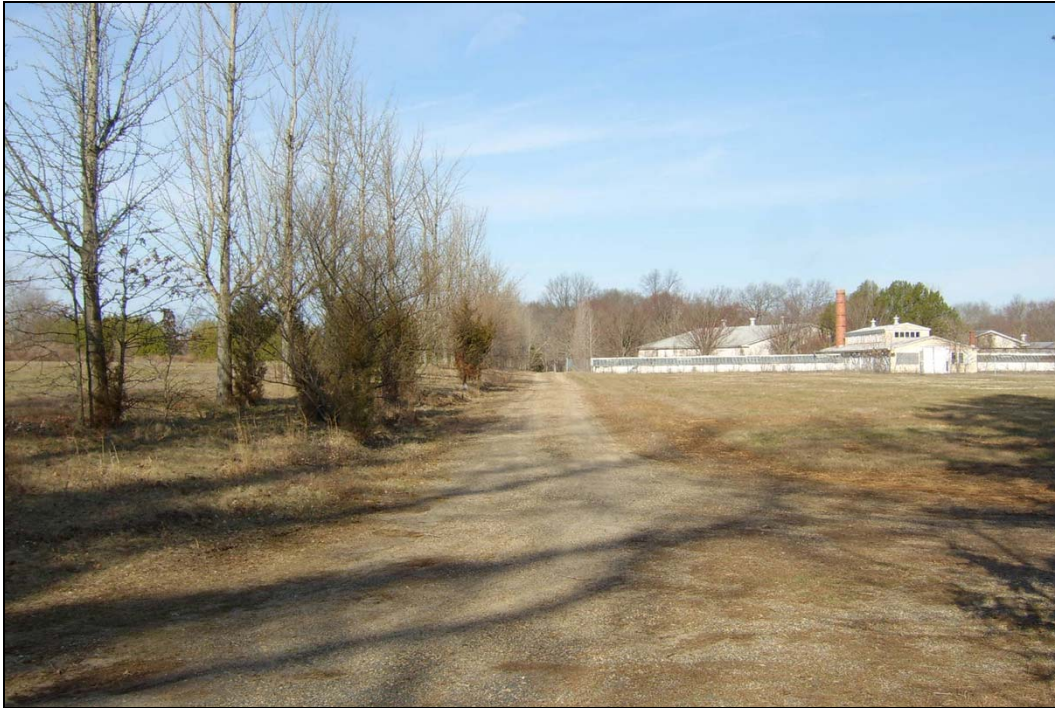
Figure III.27. This view looks west from the eastern gravel road. Here it intersects with another gravel road that extends from the entry landscape out toward the core. Princeton Sentry ginkgo line the road to the south (left). Courtesy Robert von Zumbusch. (R-PRN-RvZ-07013 D9-001.JPG)

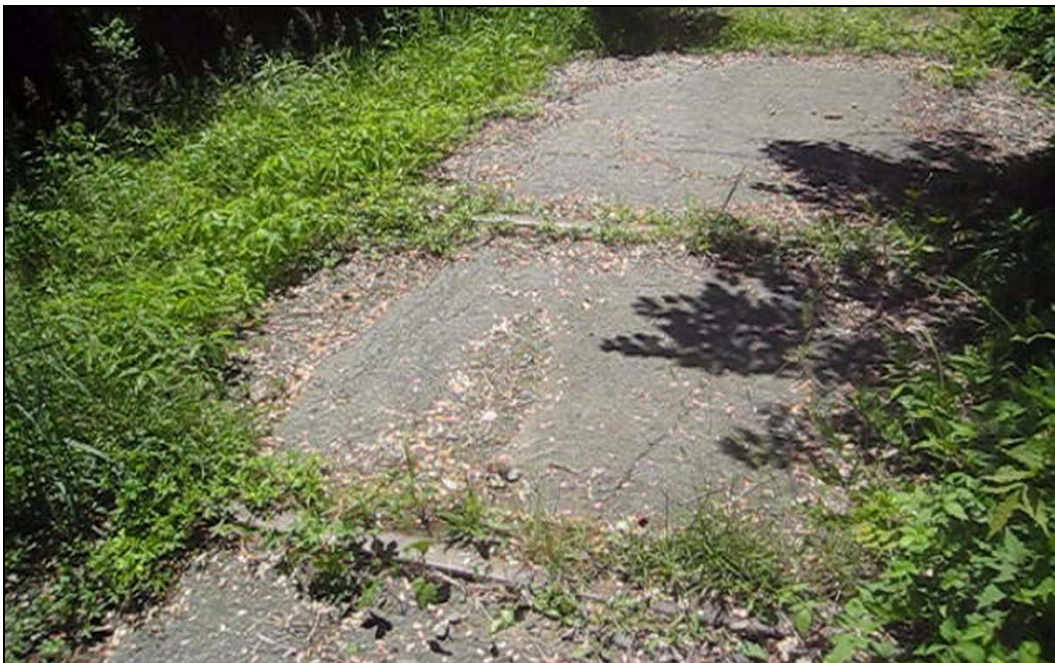
Figure III.28. A portion of railroad track remains in this asphalt patch at the west edge of the former wholesale nursery yard. This provides a strong interpretive feature to understand the historic transportation corridor. Courtesy Heritage Landscapes. (R-PRN-19May09-0074.JPG)

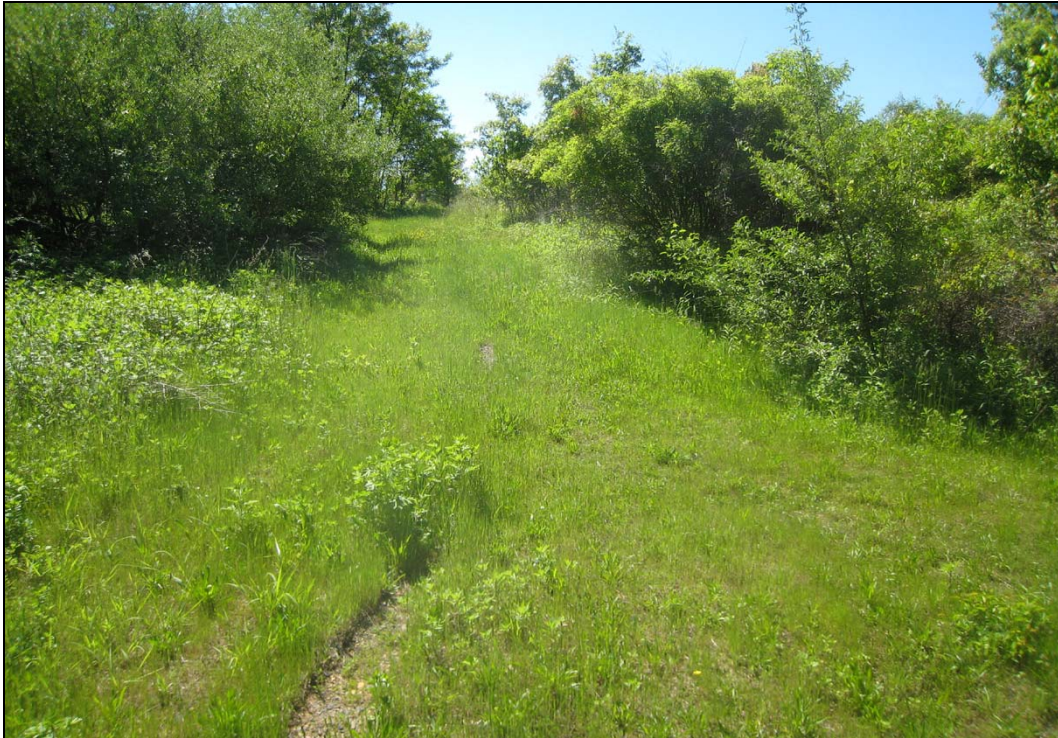
Figure III.29. This image looks west along a turf road that extends through a former production field. The turf here is taller and more overgrown than on other roads that appear to have been mown more recently. Courtesy Heritage Landscapes. (R-PRN-19May09-0133.JPG)

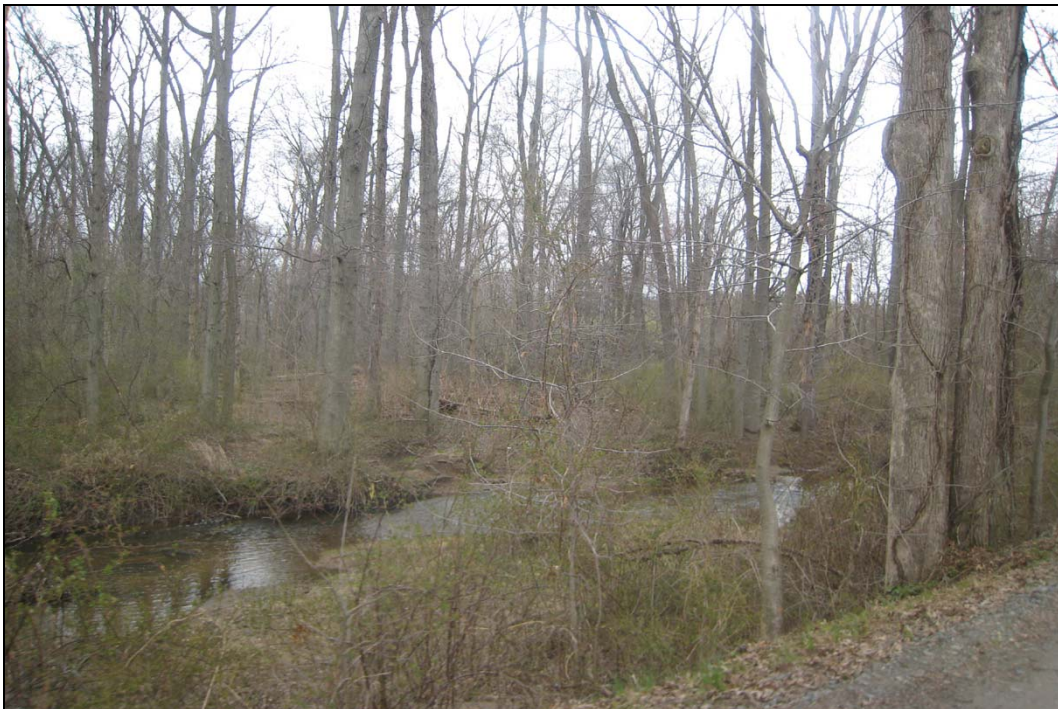
Figure III.30. An unnamed secondary brook runs alongside Railroad Avenue, visible in the right-hand foreground. Courtesy Heritage Landscapes. (R-PRN-Apr09-0069.JPG)

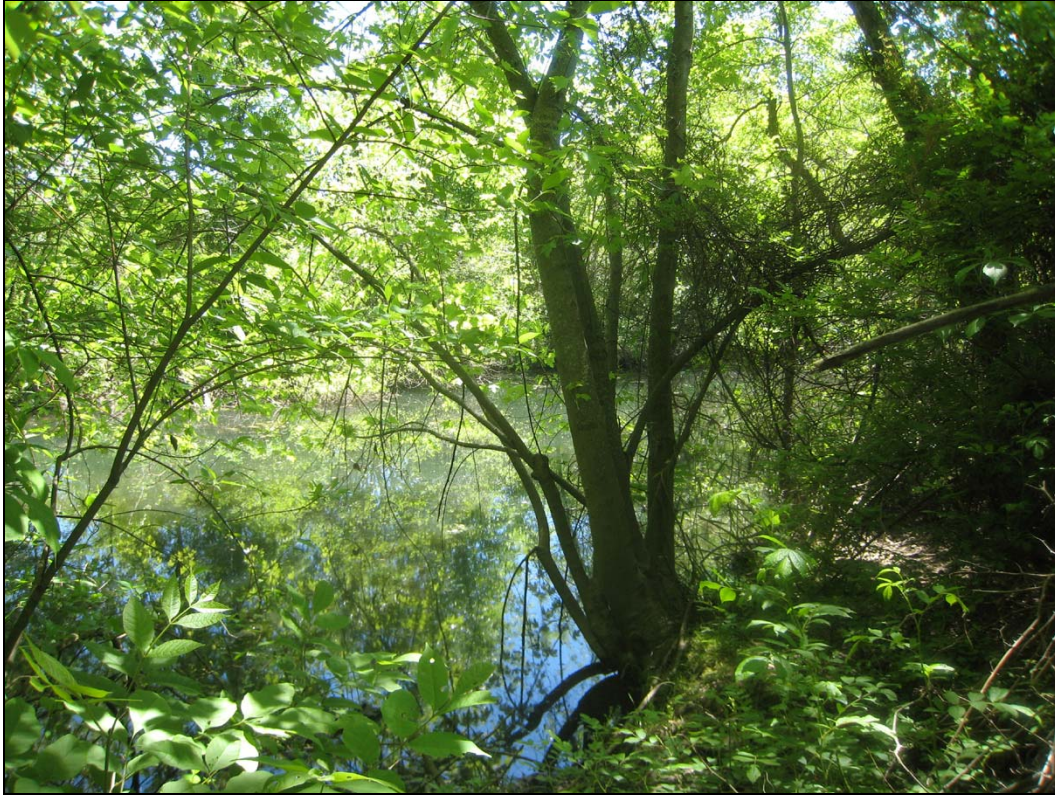
Figure III.31. Prolific vegetation surrounds the widened portion of the north-south brook. This portion of the brook is located at the east edge of the former distribution yard and likely contributes to the wetter ground conditions. Courtesy Heritage Landscapes. (R-PRN-19May09-0085.JPG)

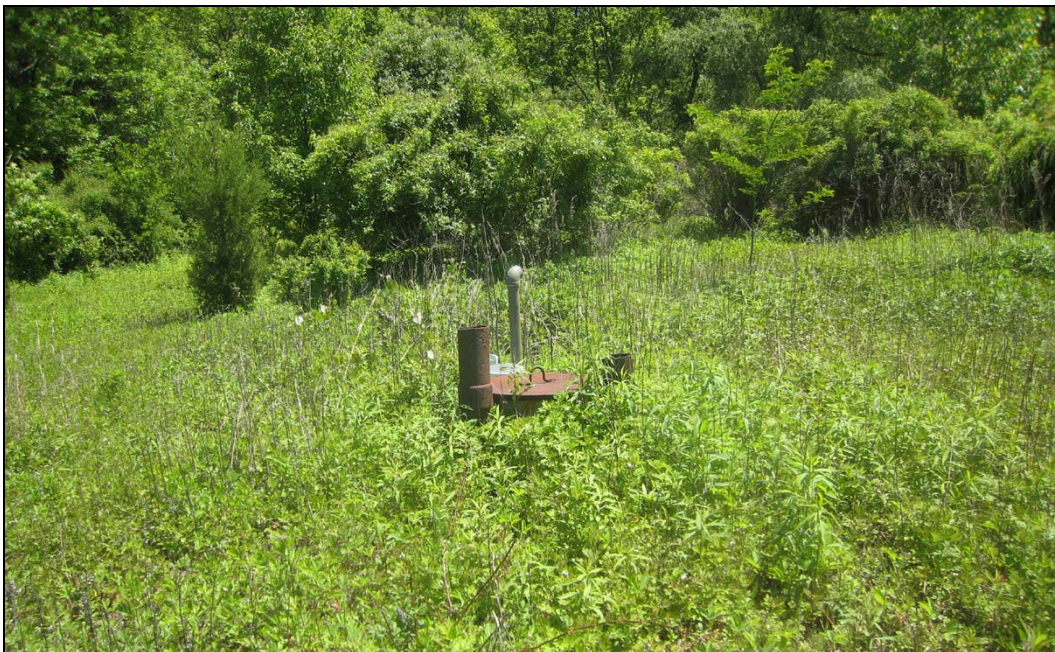
Figure III.32 Extant features from the former irrigation system can be found throughout the landscape. Courtesy Heritage Landscapes. (R-PRN-19May09-0096.JPG)

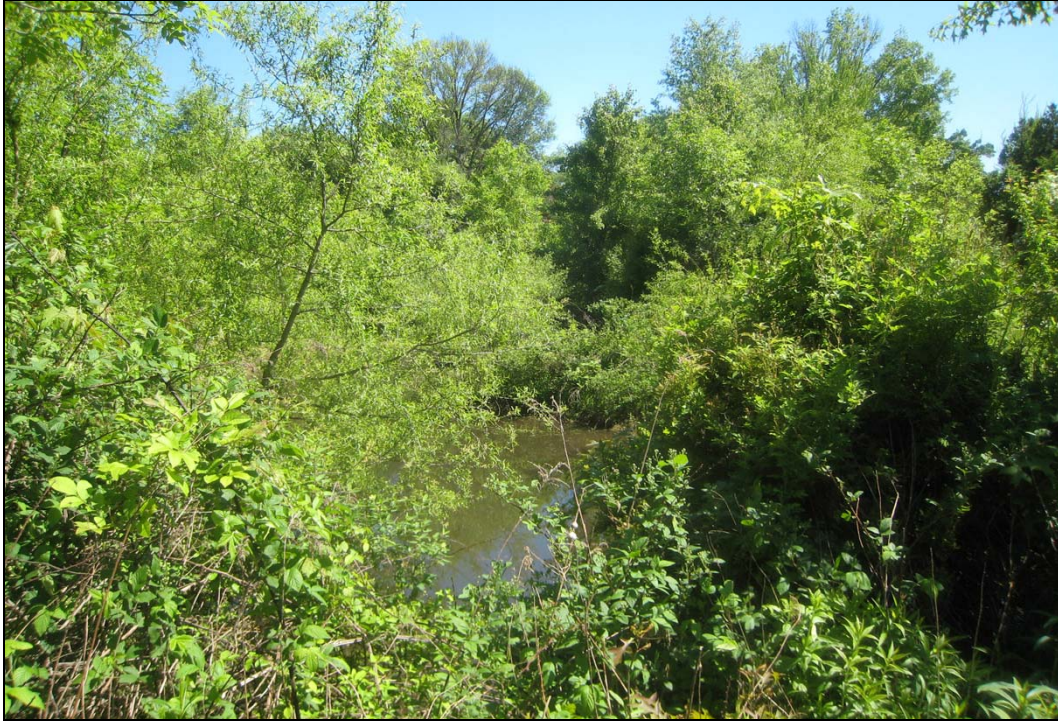
Figure III.33. A manmade pond, originally created to solve a drainage problem, is located in the Flemer Arboretum. Dense vegetation, including several young pin oak, surrounds the water feature. Courtesy Heritage Landscapes. (R-PRN-19May09-0023.JPG)

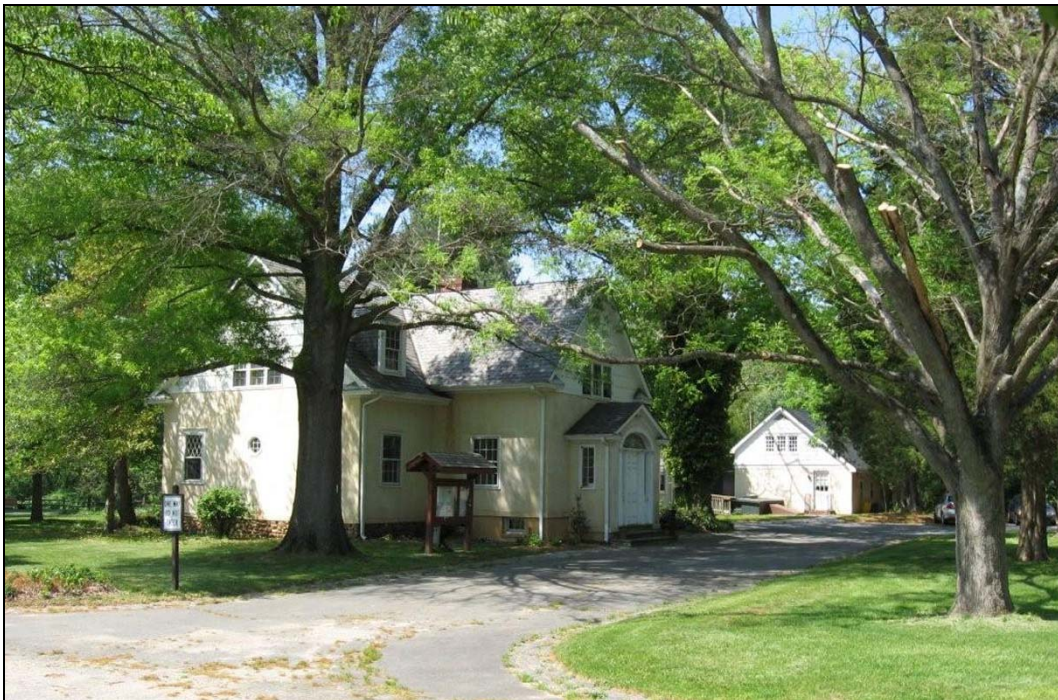
Figure III.34. The former Princeton Nurseries office building and blacksmith shop provide facilities for the Delaware & Raritan Canal State Park today. Courtesy Robert von Zumbusch. (R-PN-RvZ 003 (6).jpg)

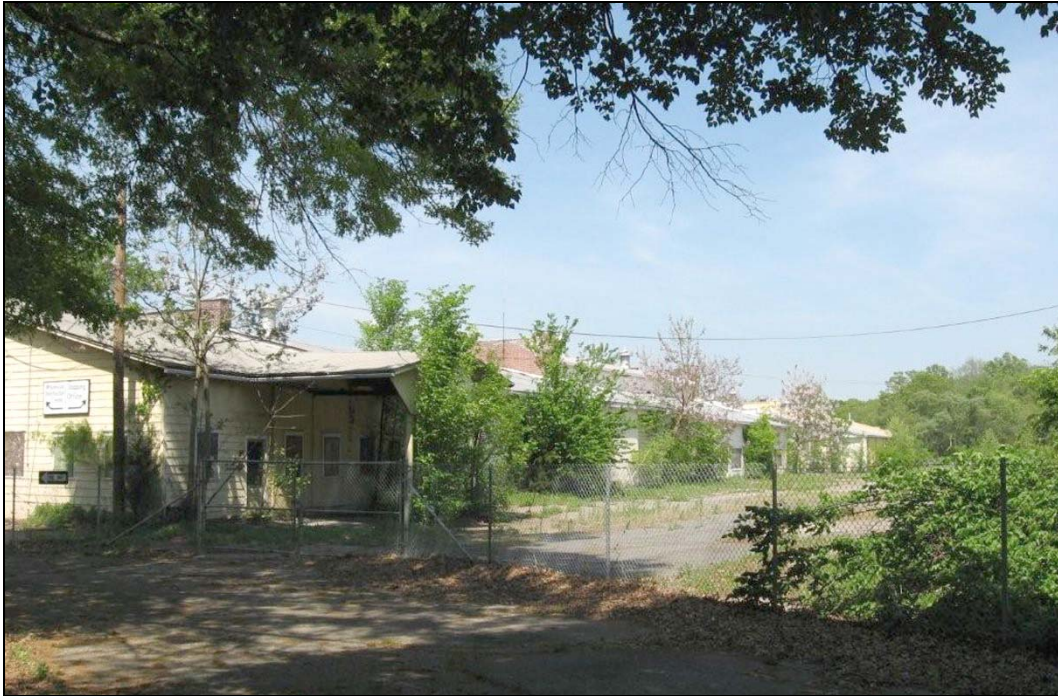
Figures III.35. This view depicts the current condition of the packing shed. It has deteriorated over time and volunteer vegetation grows along the foundation. A chain link fence has been erected to restrict public access to this building as well as the tree storage building and propagation house. Courtesy Robert von Zumbusch. (R-PN-RvZ 003 (10)-adj.jpg)

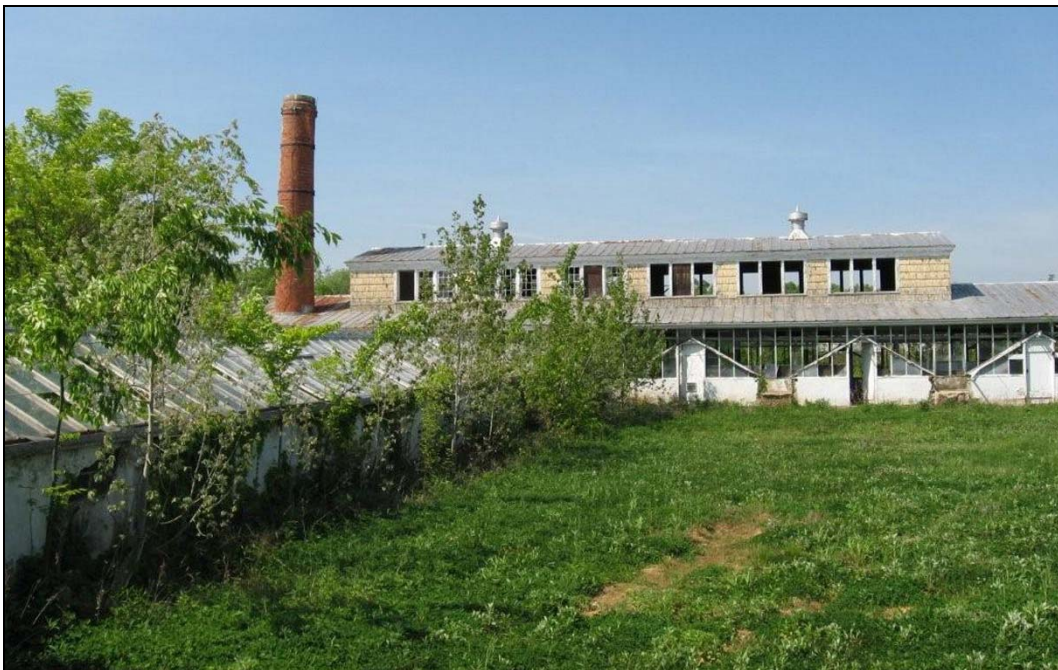
Figure III.36. This view, taken from inside the chain link enclosure, illustrates the disrepair that has occurred at the propagation house and extant greenhouses. Courtesy Robert von Zumbusch. (R-PN-RvZ 003 (32).jpg)

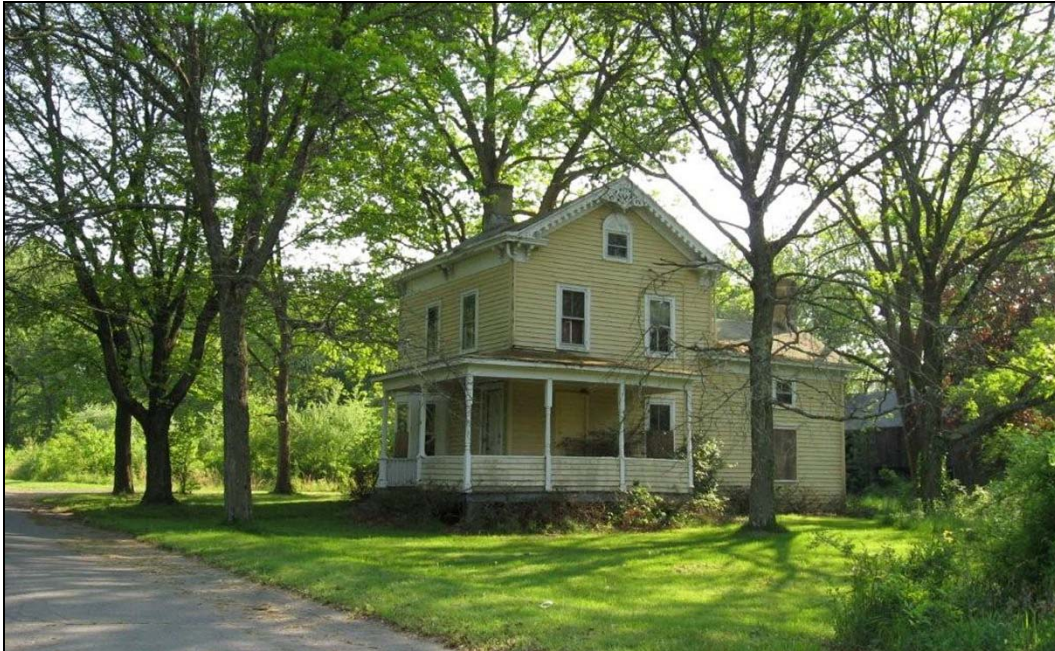
Figure III.37. A number of former worker residences remain in place, but long vacant, on Greenwood Avenue. The houses have historic preservation easements and are now being restored/ rehabilitated. This residence reflects the yellow and white color scheme implemented by William Flemer Jr. Courtesy Robert von Zumbusch. (R-PN-RvZ 003 (60).jpg)

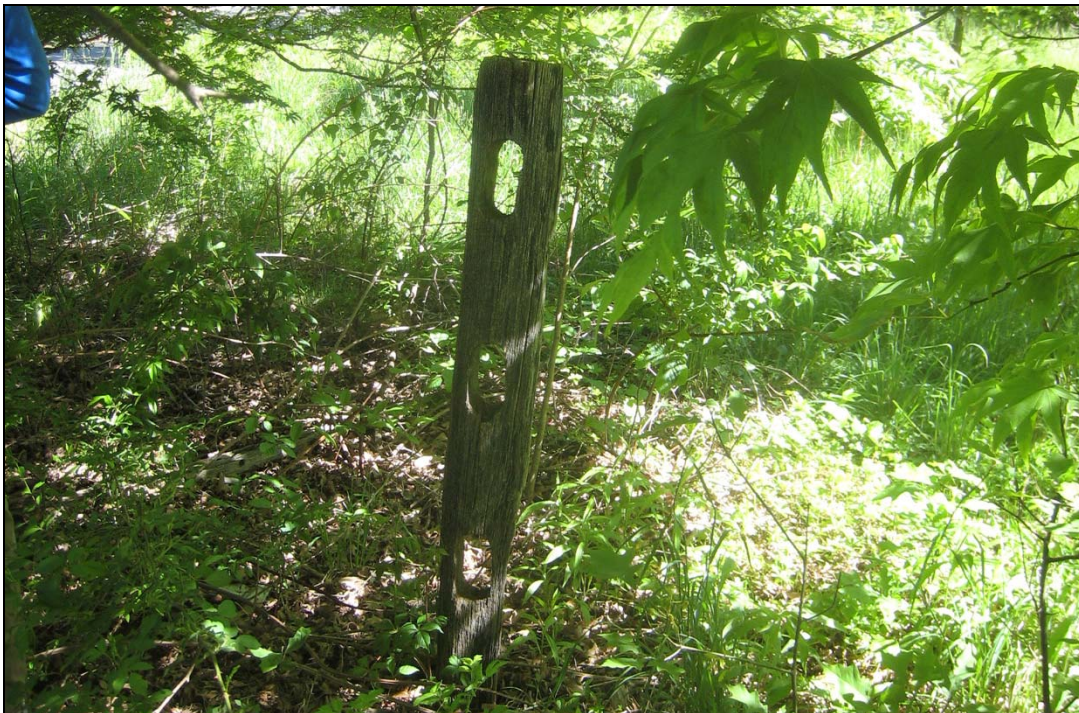
Figures III.38. A wooden post that once held three horizontal rails remains standing at the west edge of the Flemer Arboretum. Courtesy Heritage Landscapes. (R-PRN-19May09-0009.JPG)

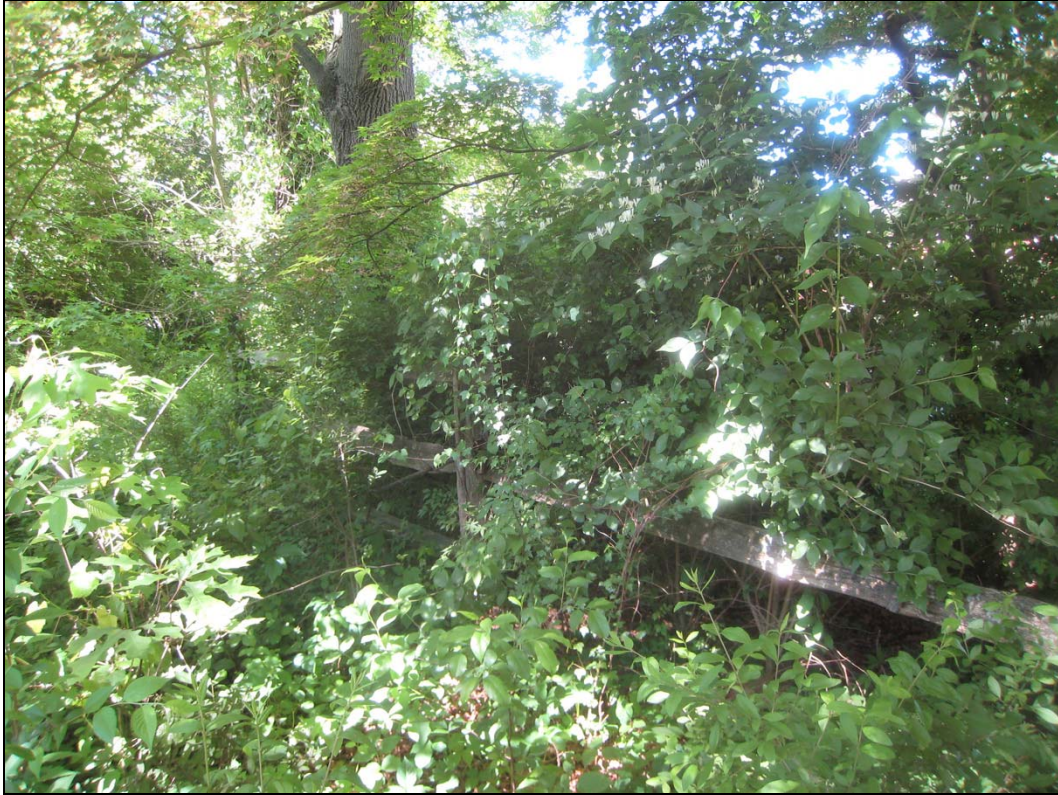
Figure III.39. At the southern edge of the Flemer Arboretum, a portion of the wooden post and rail fence remains in the landscape. Prolific vegetation impacts the historic resource. Courtesy Heritage Landscapes. (R-PRN-19May09-0014.JPG)

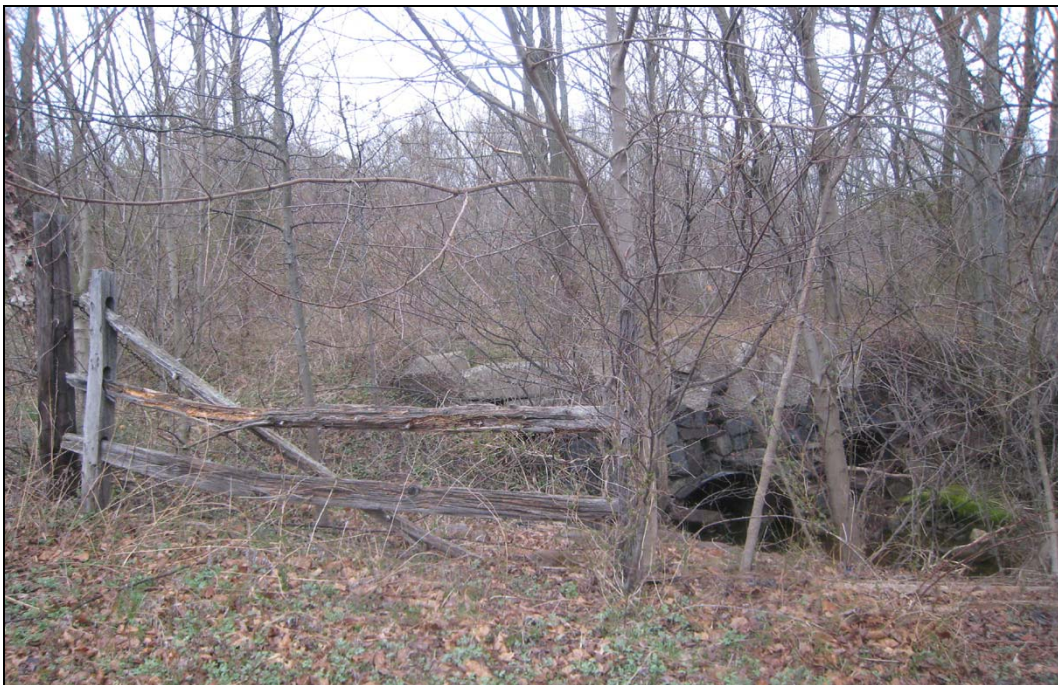
Figure III.40. Additional post and rail fencing remains as a barrier between Railroad Avenue and the stone culvert. Courtesy Heritage Landscapes. (R-PRN-Apr09-0093.JPG)

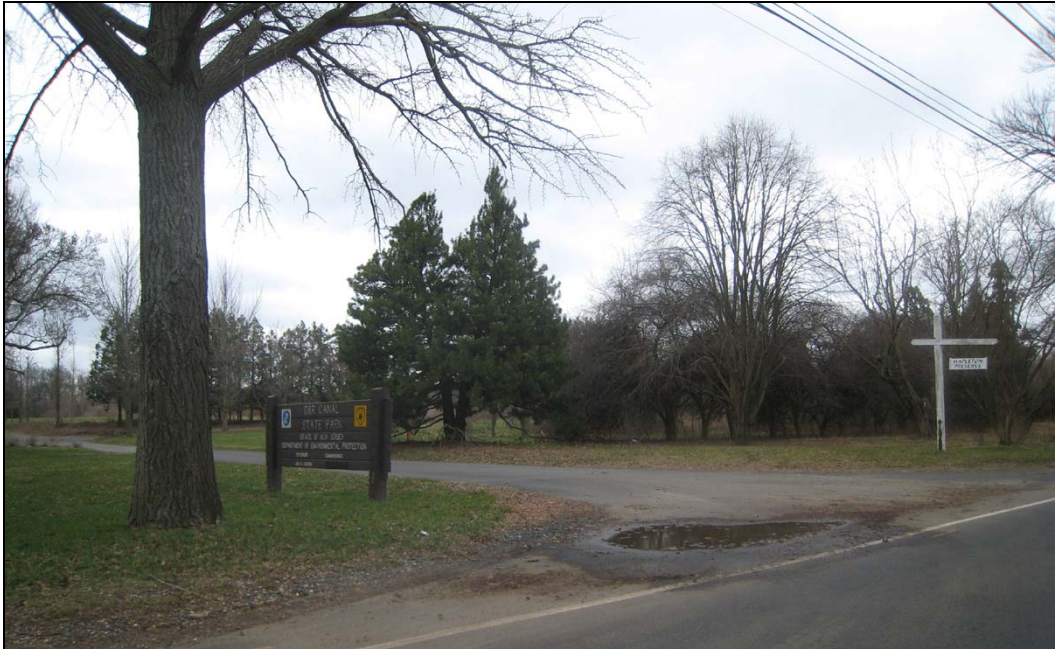
Figure III.41. Two signs mark the entry drive. The brown sign notes this as the site of the Delaware & Raritan Canal State Park headquarters and the white sign notes this is the entry into Mapleton Preserve. Courtesy Heritage Landscapes. (R-PRN-Apr09-0073.JPG)

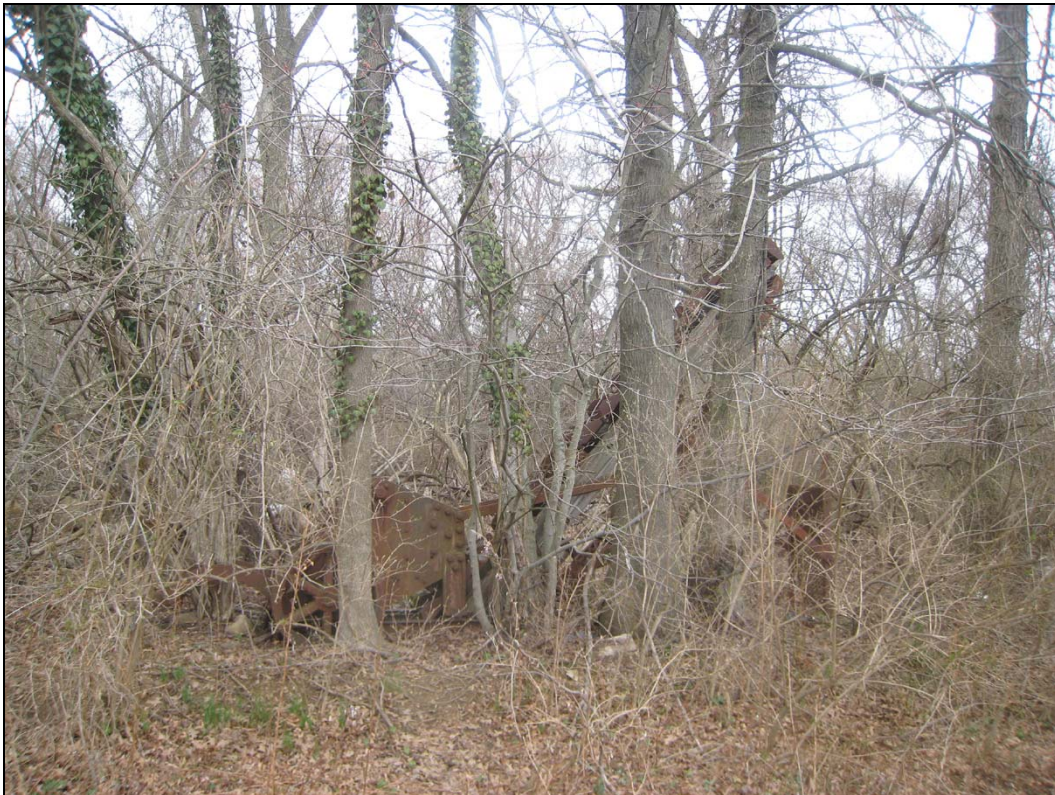
Figure III.42. A rusty rock picker remains in the landscape today. It is an intriguing folly in the landscape. The spread of vegetation nearly completely obscures it once the plants produce leaves. Courtesy Heritage Landscapes. (R-PRN-Apr09-0054.JPG)
